# structural health monitoring of composites for aircraft structures

<sup>a</sup>QuEST Global Engineering, Ground Floor, Building-5 B, SEZ (Pritech II),  
Bangalore, Karnataka - 560 103, India

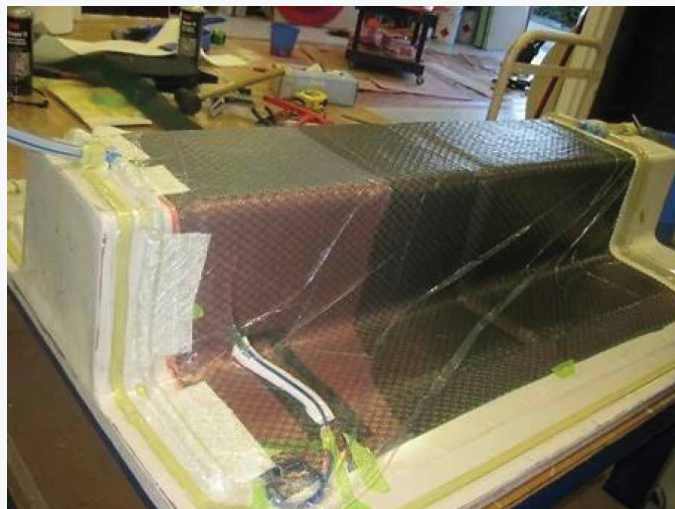
Figure 3: Top-hat-stiffener manufacturing with VARTM

For the current study, the specimens are manufactured using Vacuum Assisted Resin Transfer Moulding (VARTM) which is a closed-mould process, providing high strength, high stiffness and good surface finish.

(DB) – 611 gsm, Vinylester SPV 6036 (FGI) resin and Norex CHM-50 hardener. The layup sequence of the specimens is presented in Table 2. A snapshot of the Top-hat-stiffener specimens manufactured by VARTM is shown in Figure 3. The specimens are cured under the vacuum bag for 24 hours at a temperature of 20°C.

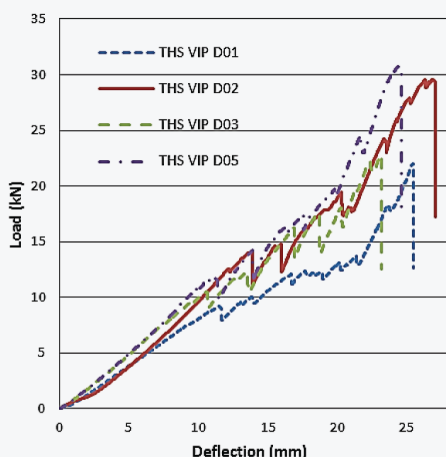
Figure 5: Load deflection plot

CSM-450 gsm layers. The load-deflection behaviour of this layup is shown in Figure 5. An initial stiffness of 1 kN/mm is seen until the first failure (Table 3).

Initial failure of the four specimens tested occurred around 11 mm deflection. For specimen ‘THS VIP D02’, twelve distinguishable load drops are seen on the load-deflection plot in Figure 5. Matrix cracking occurred at 12.48 kN and 11.85 mm deflection.

A significant load drop of 2.76 kN occurred at 13.87 mm deflection. This was a crack between the second and third layers at the radius of the left crown bend. With further application of load, the structure continued to take up the load until the right crown bend failed due to delamination and eccentric loading began on one side of the specimen at 15.66 mm (14.48 kN load). Upon further

loading, both the crown bends started to disappear and, at 20 mm (18.91 kN load), the right flange bend suffered a major crack between the fourth and fifth layers. A secondary stiffness started to appear and, at 23.33 mm deflection (24.22 kN load), the left flange bend lost its stiffness and delamination occurred between the fourth and fifth layers. Further loading caused delamination propagation between other layers and the structure finally collapsed at 27.04 mm d and 29.57 kN The laminate sheared away at the left flange base below the edge of the steel plate. Load drops are shown in Figure 5 and the damage process is shown in Figure 6.
